National Dam Safety Program. Dalton
Run Dam (NDS-I.D.-232), Ohio River Basin,
Dalton Run, Somerset County, Pennsylvania
Phase I Inspection Report.

PHASE I REPORT
NATIONAL DAM INSPECTION PROGRAM

NAME OF DAM: Dalton Run Dam
STATE LOCATED: Pennsylvania
COUNTY LOCATED: Somerset
STREAM: Dalton Run, tertiary tributary of Conemaugh River
DATE OF INSPECTION: April 24 and May 4, 1978

DALTON RUN DAM
NDS I.D. NO. 232
APRIL 24, 1978

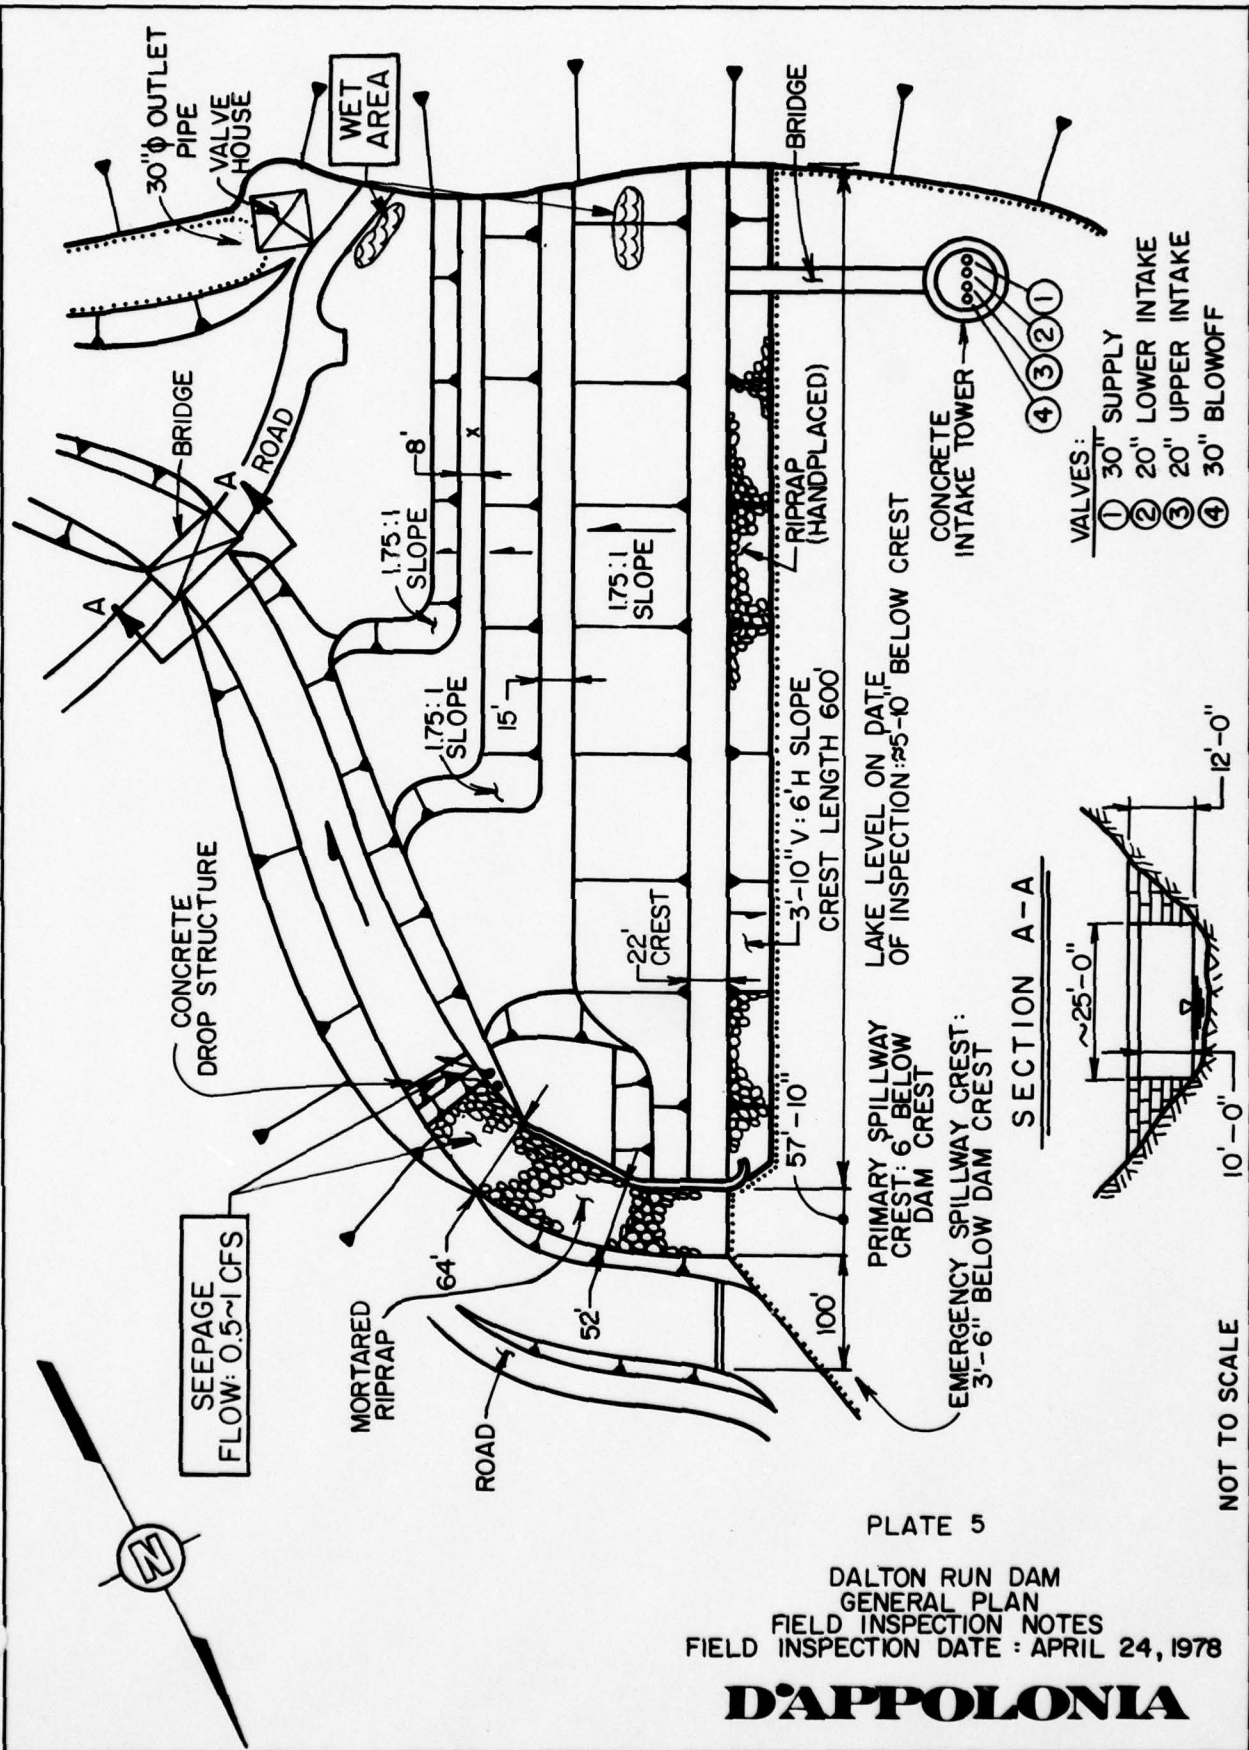
PLATE 5

Two wet areas were observed (Plate 5), one at the toe near the valve house and a second on the embankment adjacent the right abutment. No perceivable seepage was associated with these wet areas.

DALTON RUN DAM
GENERAL PLAN
FIELD INSPECTION NOTES
FIELD INSPECTION DATE: APRIL 24, 1978

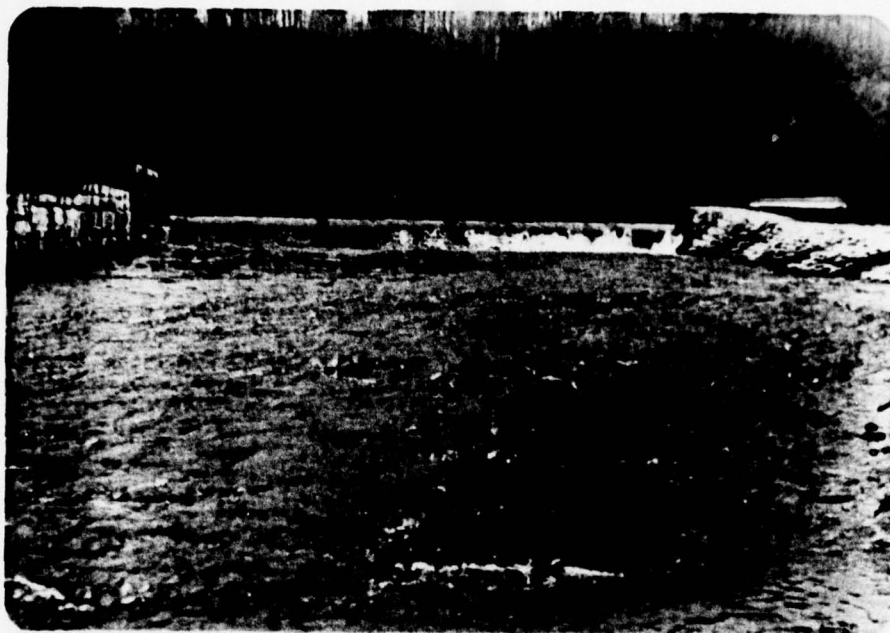
VISUAL EXAMINATION OF	OBSERVATIONS	REMARKS OR RECOMMENDATIONS
CONCRETE WEIR	NO VISUAL SIGNS OF DISTRESS. (NORTH END OF THE WEIR IS APPROXIMATELY 2-INCHES LOWER THAN SOUTH END)	NO REPAIRS ARE RECOMMENDED FOR WEIR SETTLEMENT PROBLEM.
APPROACH CHANNEL	GOOD CONDITION. NO OBSTRUCTIONS.	
DISCHARGE CHANNEL	MORTARED RIPRAP. SIGNS OF EROSION. WATER FLOWING BENEATH THE CHANNEL LINING AND DISCHARGING NEAR CONCRETE DROP STRUCTURE	REPAIRS RECOMMENDED.
BRIDGE AND PIERS	NONE (@ CONTROL SECTION)

Photograph No. 1
Primary spillway crest.

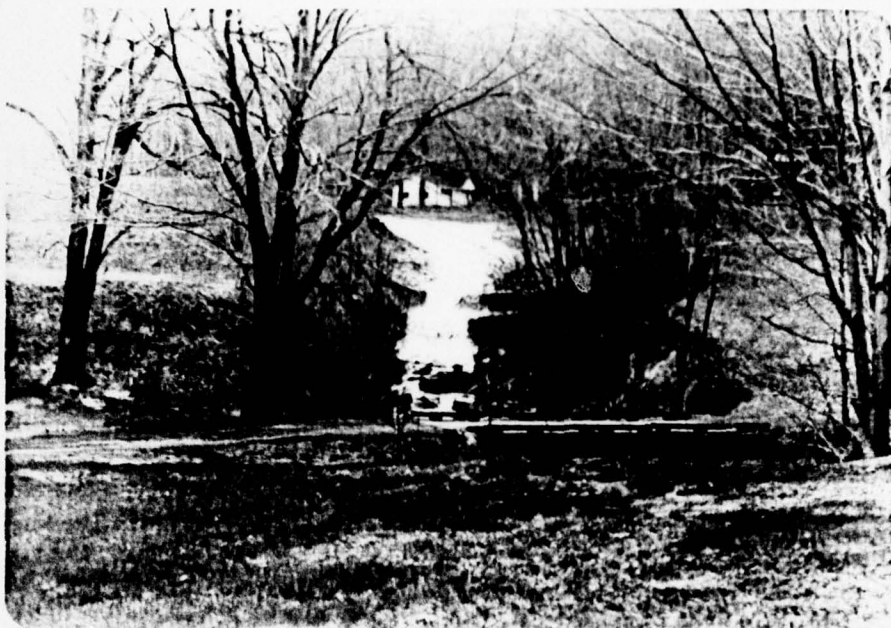
Photograph No. 5

Spillway discharge channel. Note bridge on foreground.
Bridge to gate house (Bridge No. 1).

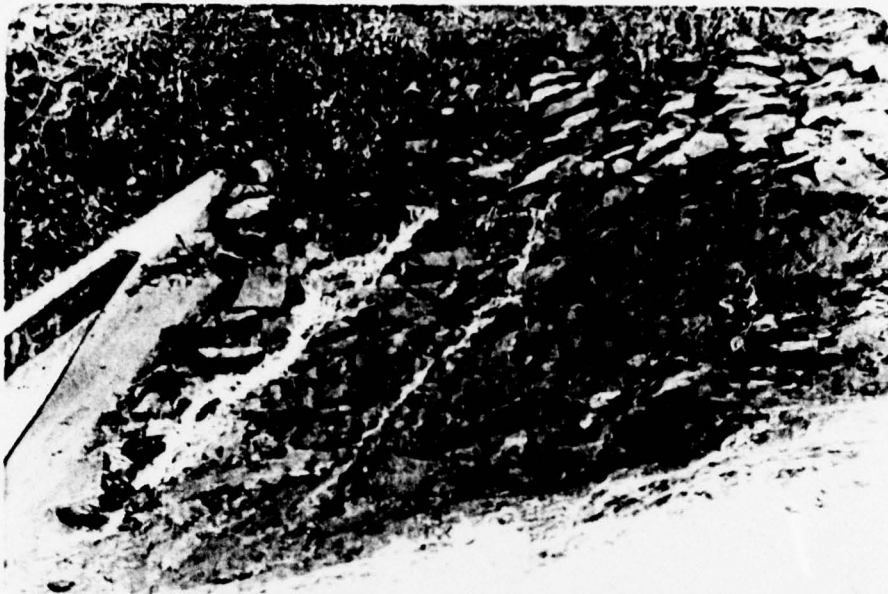
Photograph No. 7

1. The spillway discharge channel was found to show signs of surficial and internal erosion. Various seeps at the lower end of the channel indicated that water is passing beneath the grouted stone paving. Flow from one of the seepage areas located on the right side of the channel approximately 25 feet below the crest of the dam was estimated to be in the range of 0.5 to 1.0 cfs. Flow was also observed coming up through the grouted stone paving of the discharge channel.

3.2 Evaluation. In general, while the condition of the embankment is considered to be good, the condition of the spillway discharge channel is considered to be poor, with indications of internal erosion. As far as can be assessed from the downstream end, the condition of the outlet pipe also appears to be poor due to corrosion. Further evaluation of the condition of the drainpipe is required.

Seepage on the right bank (looking downstream) of spillway discharge channel.

1. The owner should evaluate the adequacy of the spillway discharge channel lining in view of the existing underseepage condition and undertake necessary repairs.
2. The owner should also evaluate the extent of corrosion and the structural adequacy of the blow-off pipe.
3. In view of "inadequate" spillway capacity, it is recommended that during periods of high runoff the owner should provide around-the-clock surveillance and have contingency plans in the event of overtopping to warn the inhabitants of the flood plain downstream.

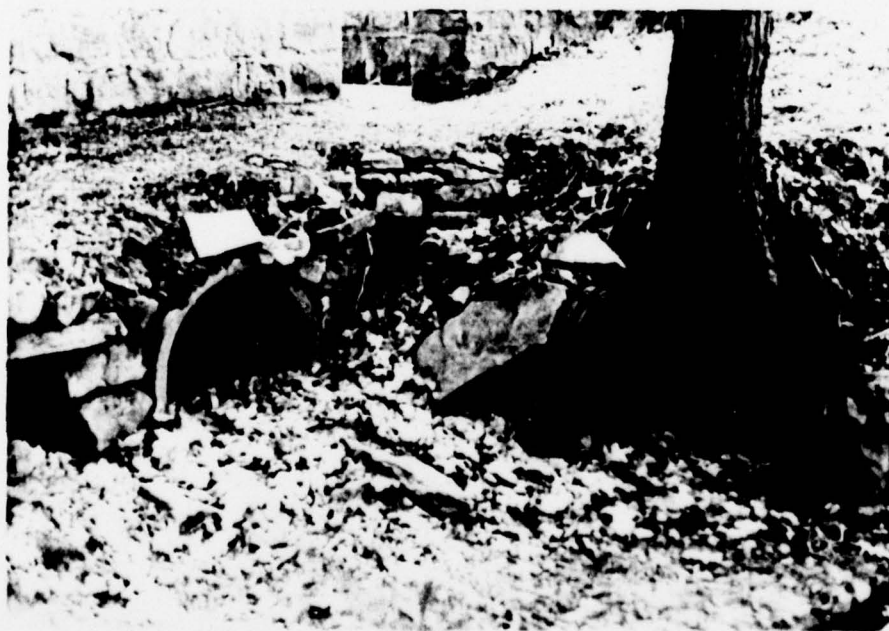
Photograph No. 8

2. The outlet end of the blow-off pipe was inspected and found to be significantly corroded.
3. Orange-colored water was observed in the outlet pipe discharge channel suggesting acid mine drainage from the adjacent hillside.

Outlet end of "blow-off" pipe.

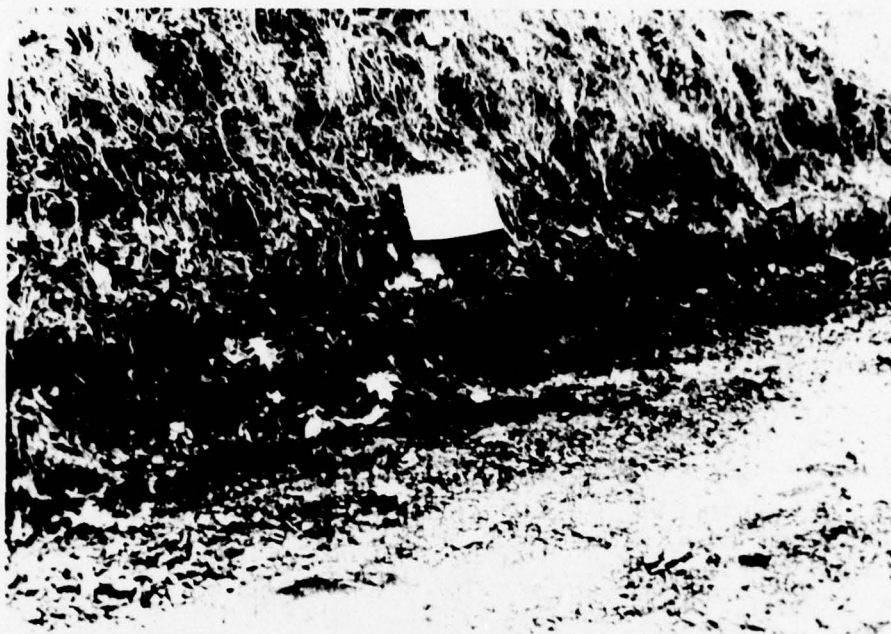
Photograph No. 9

Wet area at the toe. (See Plate 3 for location.)
